Case Study

Roughness Tester

PCE-RT 1200

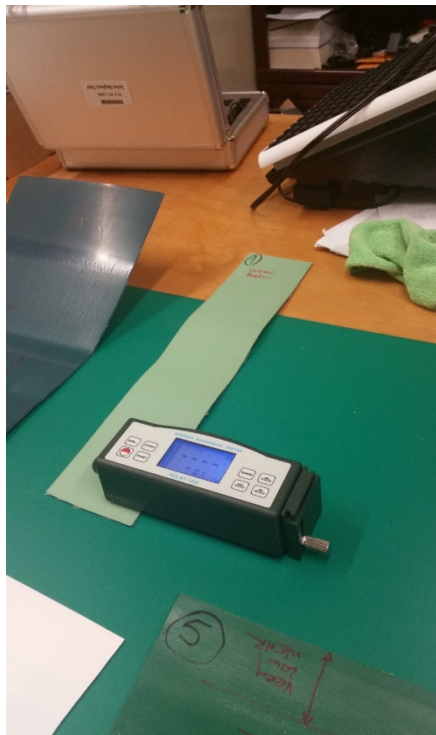
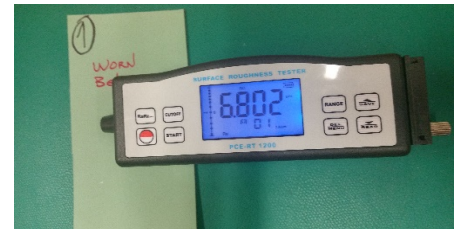
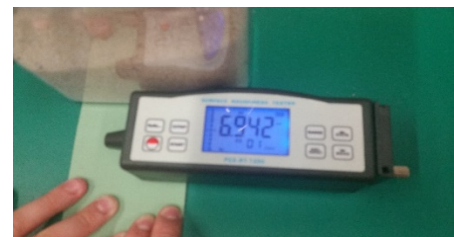
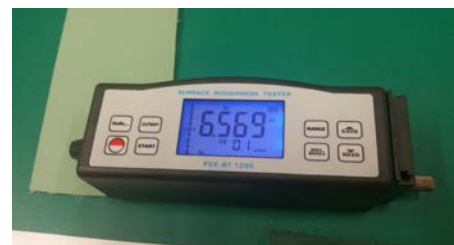
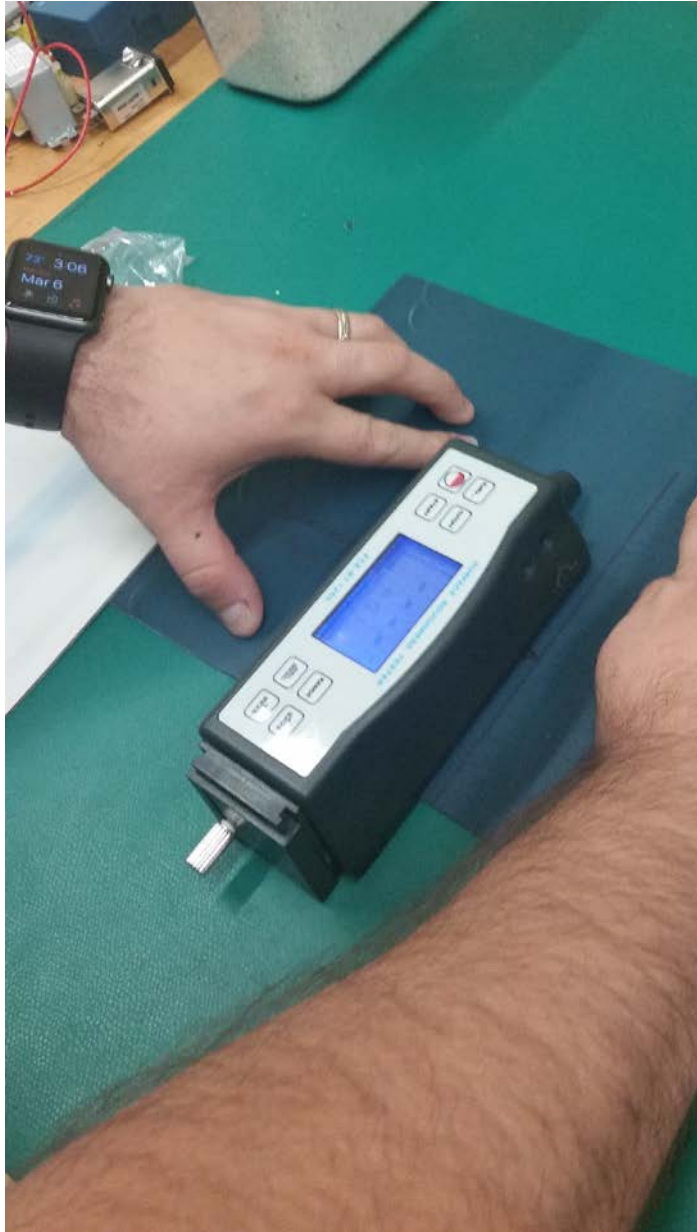
Belt Sample #1 – Worn Light Green Belt

The PCE-RT 1200 Roughness Tester was placed in three different positions on Belt Sample #1. For reporting purposes, these positions are labeled as top, middle and bottom, respectively. Measurements were made from top to bottom with the #1 appearing face up in the top corner of the sample.

| Top | 6.802 μm |
| Middle | 6.942 μm |
| Bottom | 6.569 μm |

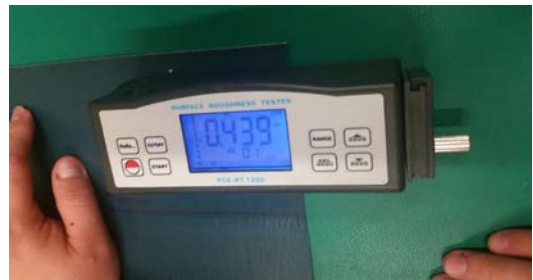
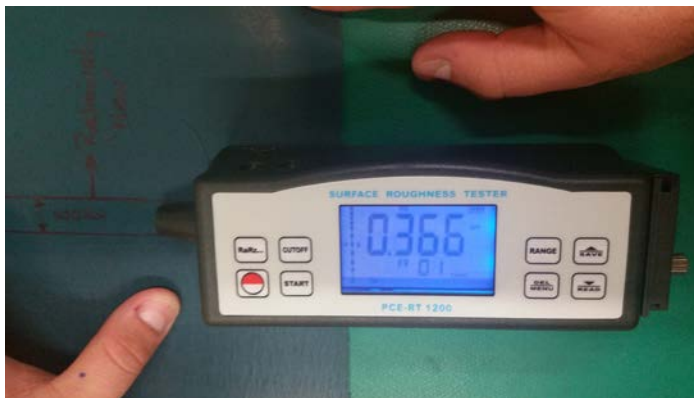
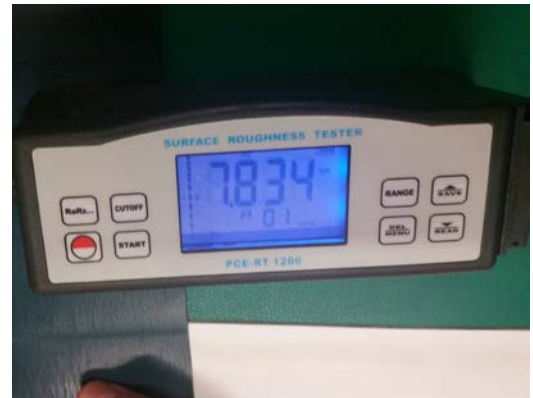
Belt Sample #2 – Worn Teal Belt

The PCE-RT 1200 Roughness Tester was placed in five different positions on Belt Sample #2. These positions were labeled by the customer as relatively new, worn, dry rot, worn and relatively new. Measurements were made from top to bottom with the #2 appearing face down in the top corner of the sample.

| Relatively New | 0.439 μm |
| Worn | 0.366 μm |
| Dry Rot | 7.834 μm |
| Worn | 2.967 μm |
| Relatively New | 0.431 μm |

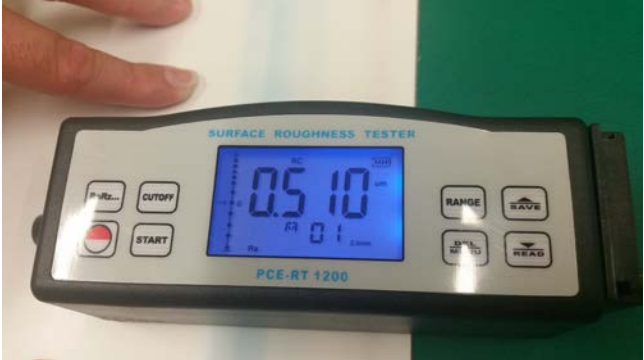
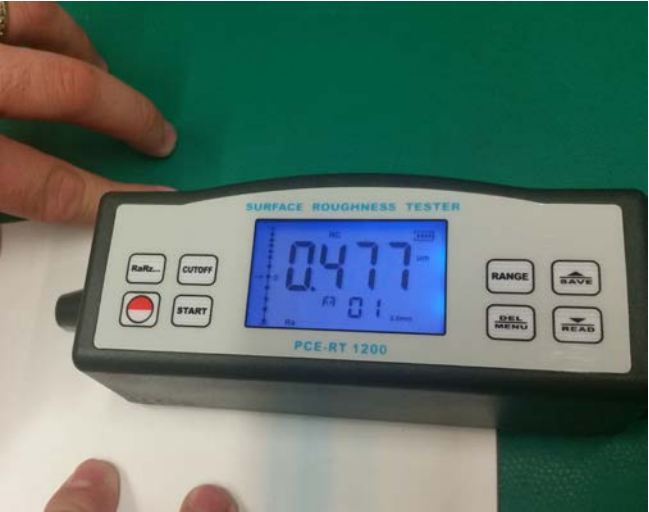
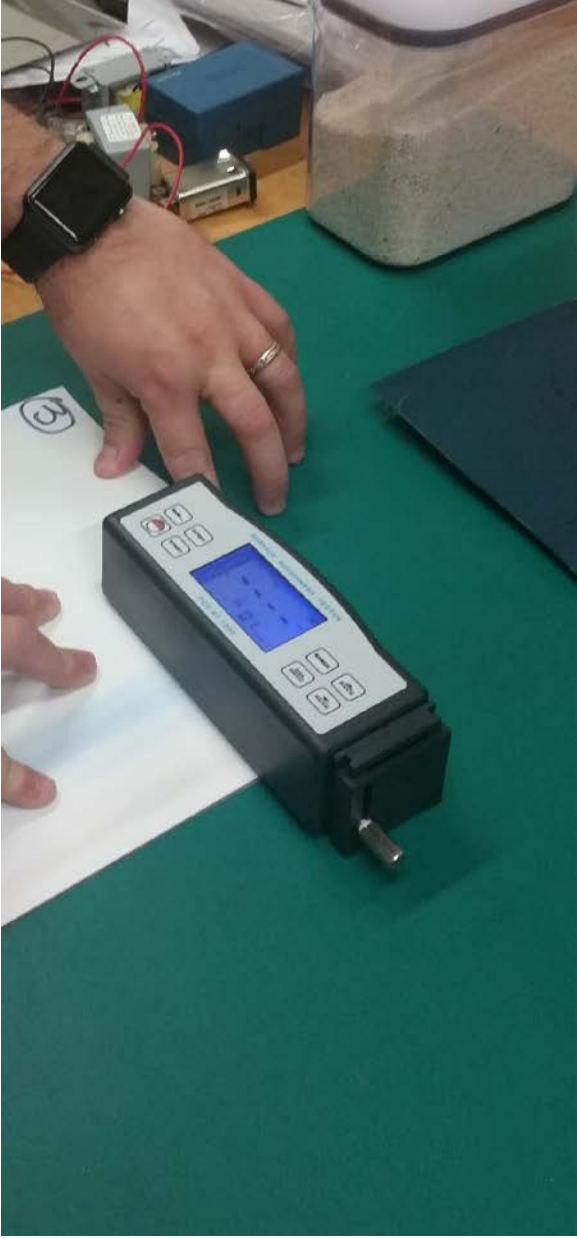
Belt Sample #3 – Worn White Belt with Blue Vertical Striping

The PCE-RT 1200 Roughness Tester was placed in three different positions on Belt Sample #3. For reporting purposes, these positions are labeled as top, middle and bottom, respectively. Measurements were made from top to bottom with the #3 appearing face up in the top corner of the sample.

| Top | 0.477 μm |
| Middle | 0.510 μm |
| Bottom | 0.457 μm |

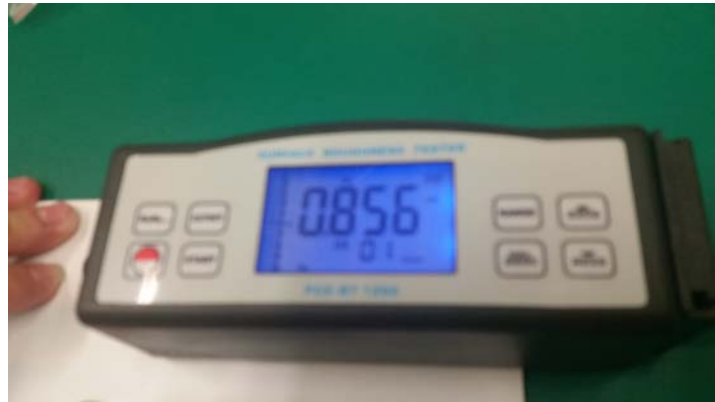
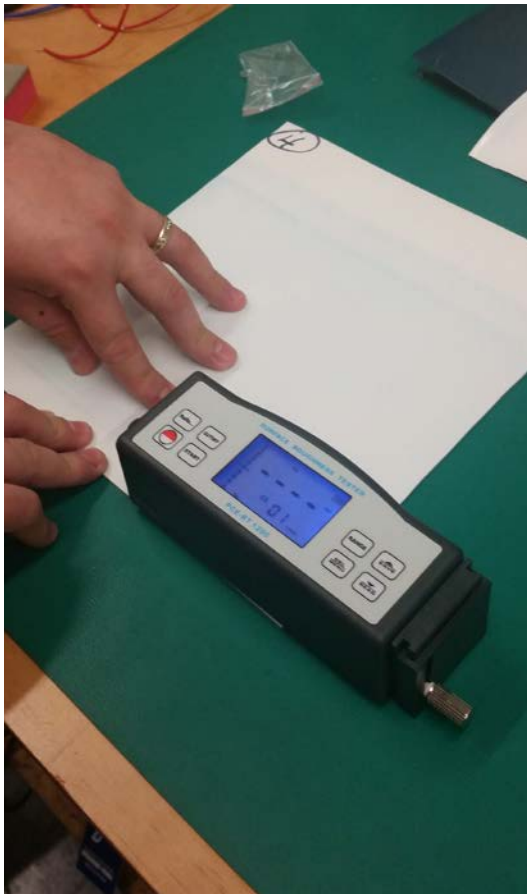
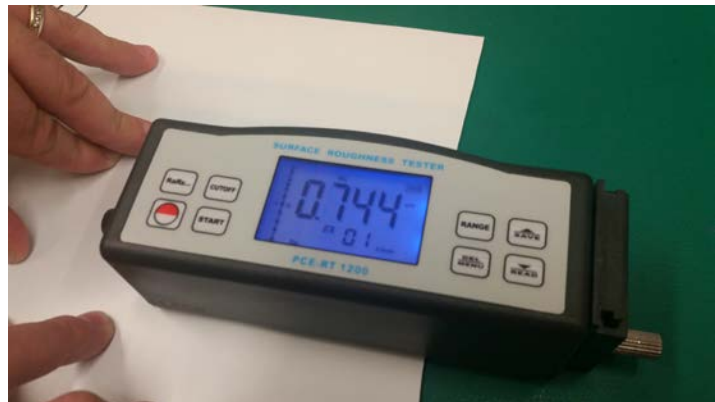
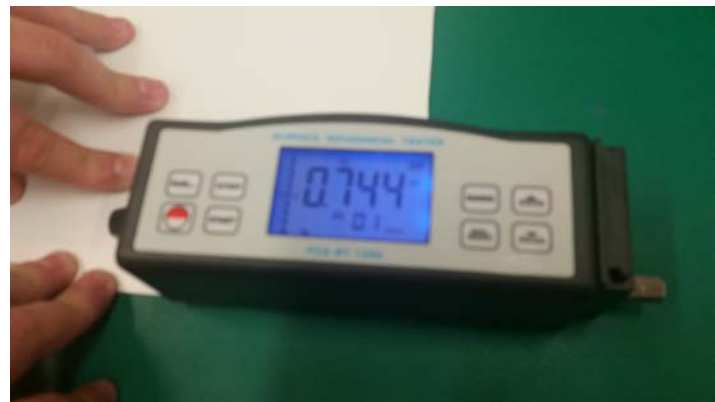
Belt Sample #4 – Worn White Belt with Blue Horizontal Striping

The PCE-RT 1200 Roughness Tester was placed in three different positions on Belt Sample #4. For reporting purposes, these positions are labeled as top, middle and bottom, respectively. Measurements were made from top to bottom with the #4 appearing face up in the top corner of the sample.

| Top | 0.856 μm |
| Middle | 0.744 μm |
| Bottom | 0.744 μm |

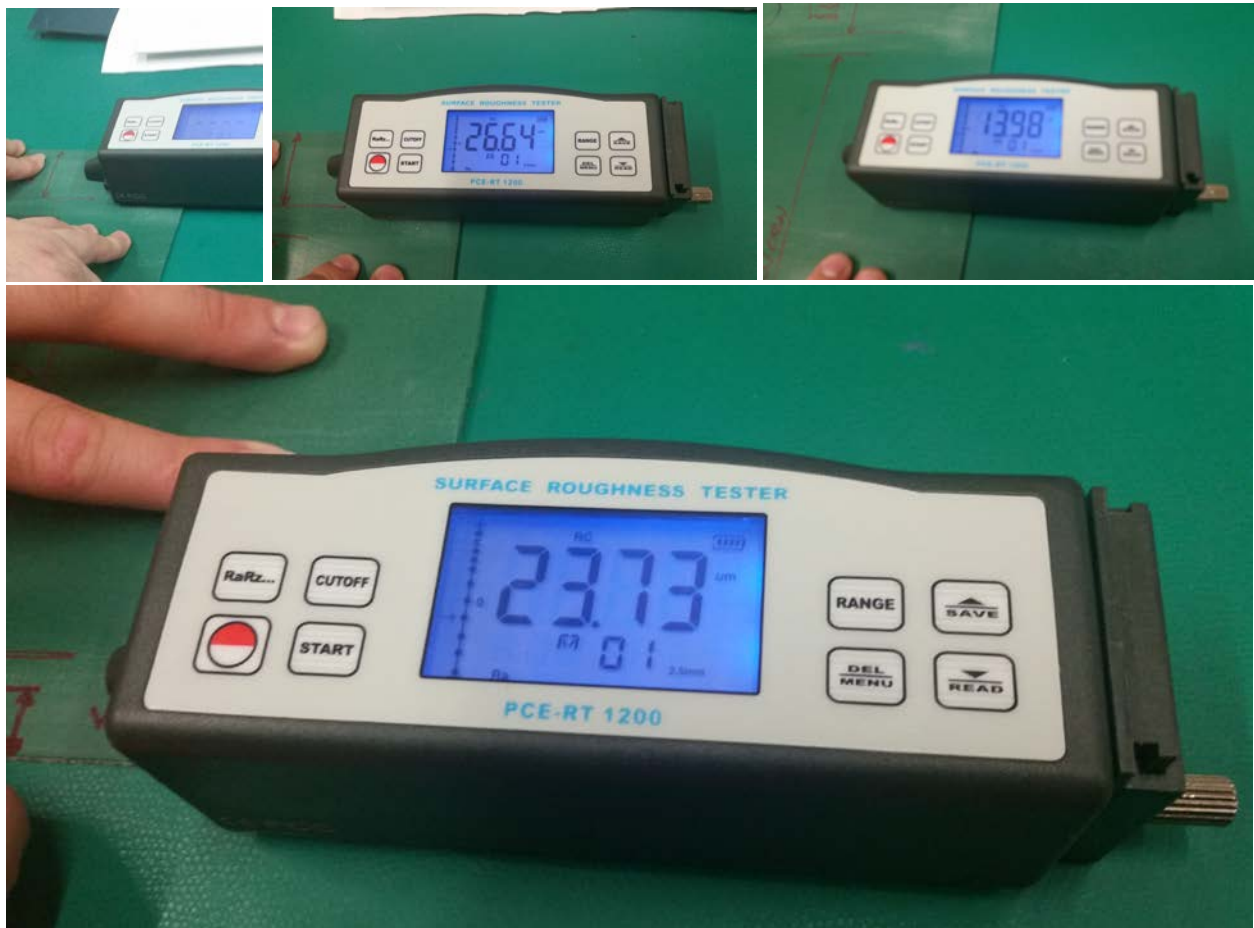
Belt Sample #5 – Worn Green Belt

The PCE-RT 1200 Roughness Tester was placed in three different positions on Belt Sample #5. These positions were labeled by the customer as very low wear, worn and very low wear. Measurements were made from top to bottom with the #5 appearing face up in the top corner of the sample.

| Very Low Wear | 26.64 μm |
| Worn | 13.98 μm |
| Very Low Wear | 23.73 μm |
